Why Indeed Did the WTC Buildings Collapse?

Published by [Brian](#) on 2006/2/24 (1529 reads)

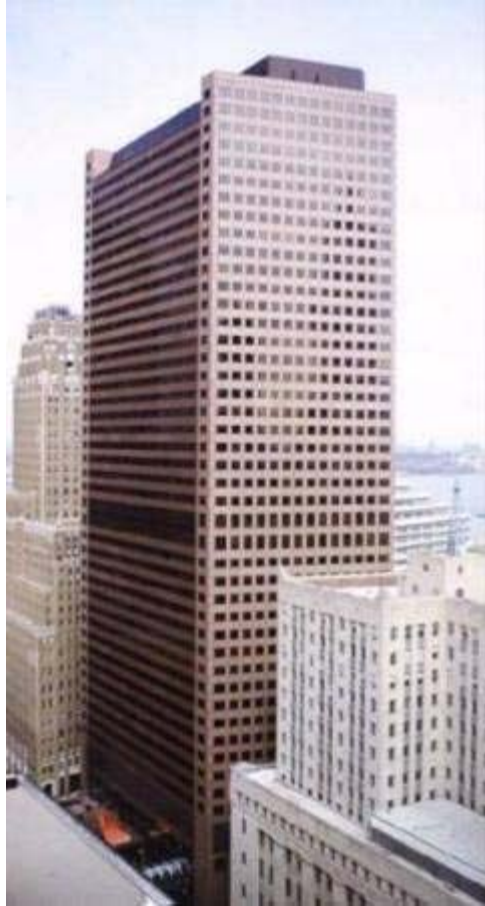
WTC 7: 47 -
Story, steel-frame building..

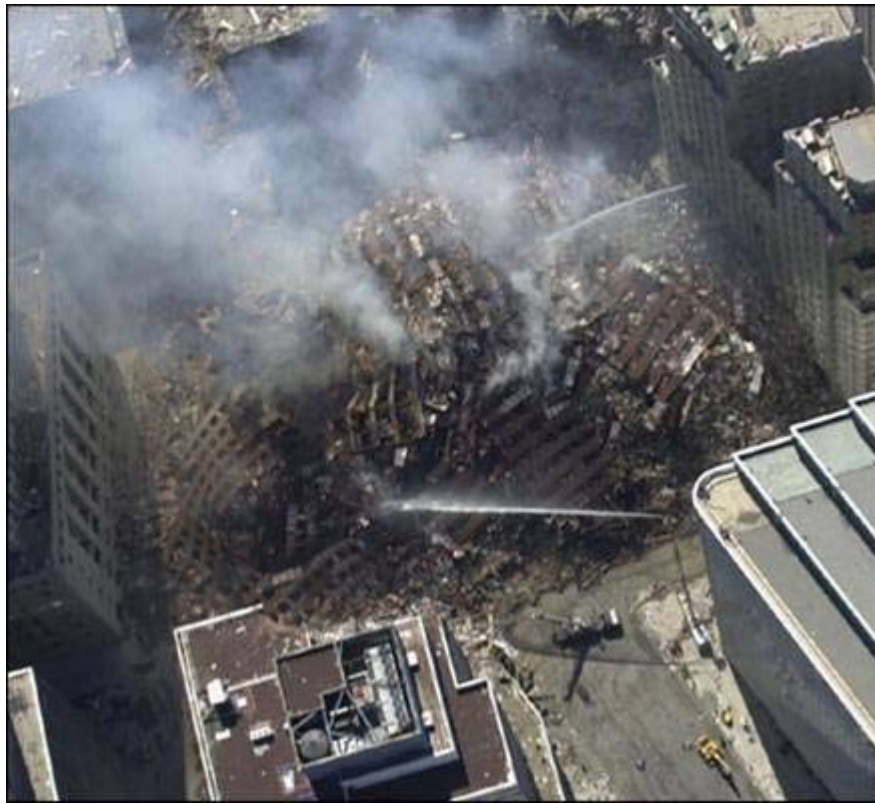
WTC 7
collapsed completely, onto its own footprint

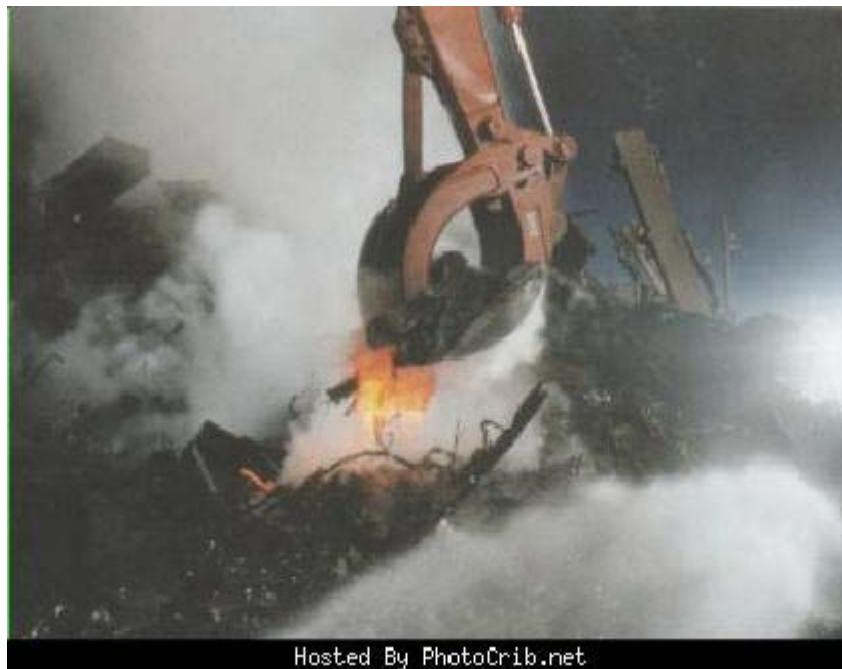
We see from the photograph above that solid metal slag existed at salmon-to-yellow-hot temperature (approx. 1550 - 1900 °F, 845 - 1040 °C.) The temperature is well above the melting temperatures of lead and aluminum, and these metals can evidently be ruled out since they would be runny liquids at much lower (cherry-red or below) temperatures. However, the observed hot specimen could be structural steel (from the building) or iron (from a thermite reaction) or a combination of the two. Additional photographs of the hot metal could provide further information and advance the research.

. The photograph below by Frank Silecchia shows a chunk of the hot metal being removed from the North Tower rubble about eight weeks after 9-11. Notice the color of the lower portion of the extracted metal -- this tells us much about the temperature of the metal and provides important clues regarding its composition, as we shall see. . .

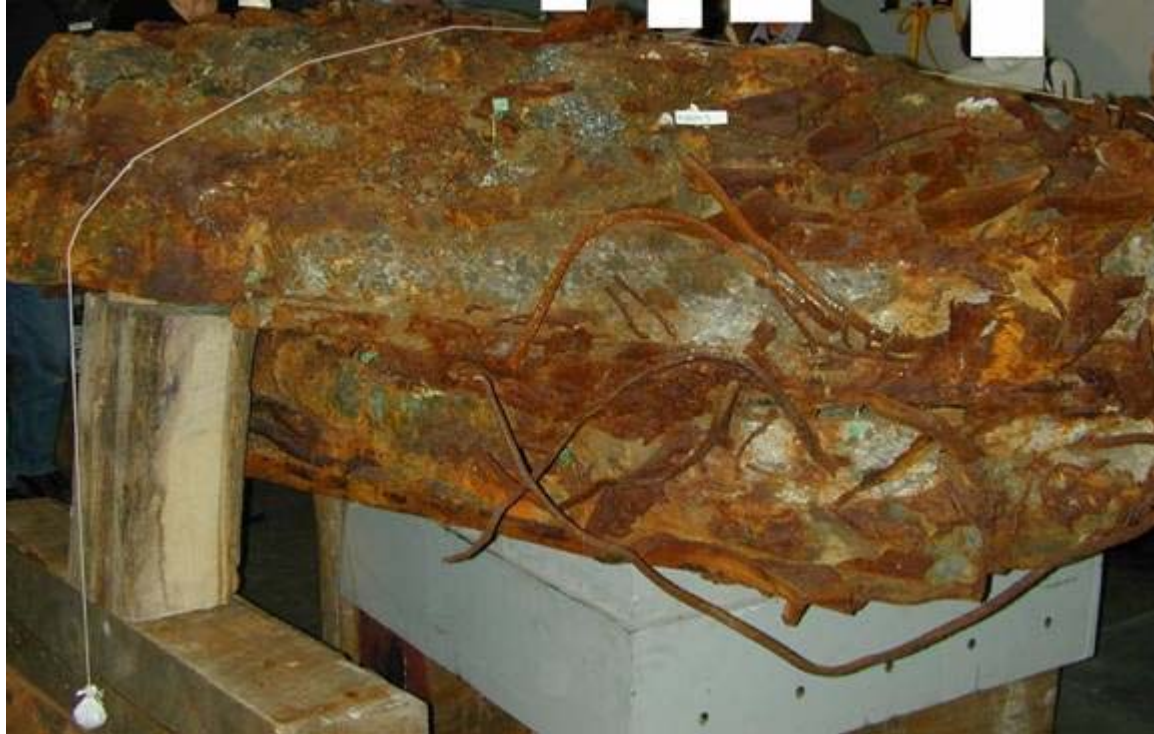
The following photograph has become available, evidently showing the solidified slag with entrained material, stored (as of November 2005) in a warehouse in New York: <!--[if !vml]-->

The abundance of iron (as opposed to aluminum) in this slag is indicated by the reddish rust observed. When a sample is obtained, a range of characterization techniques will quickly give us information we seek. X-ray energy dispersive spectrometry (XEDS) will yield the elemental composition, and electron energy-loss spectroscopy will tell us the elements found in very small amounts that were undetectable with XEDS. Electron-backscattered diffraction in the scanning electron microscope will give us phase information; the formation of certain precipitates can tell us a minimum temperature the melt must have reached. We will endeavor to obtain

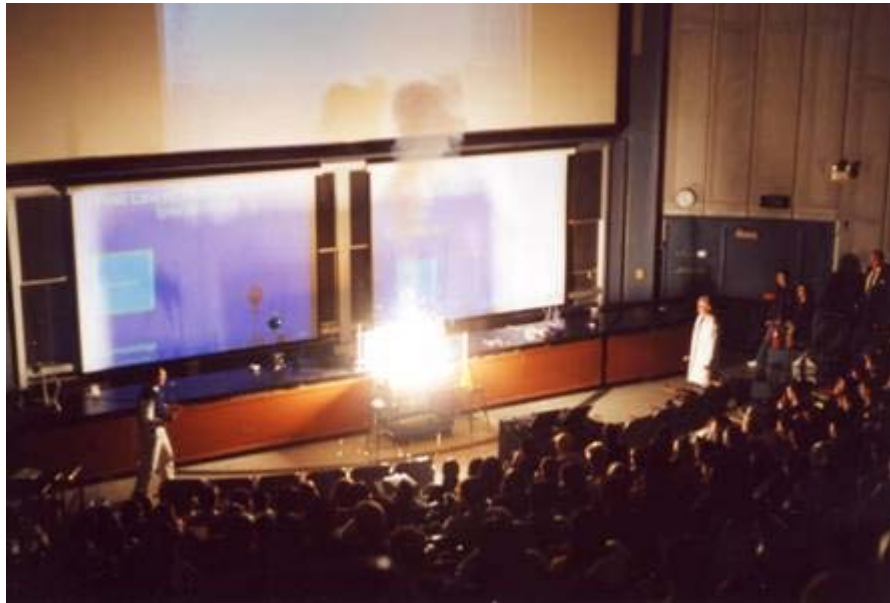
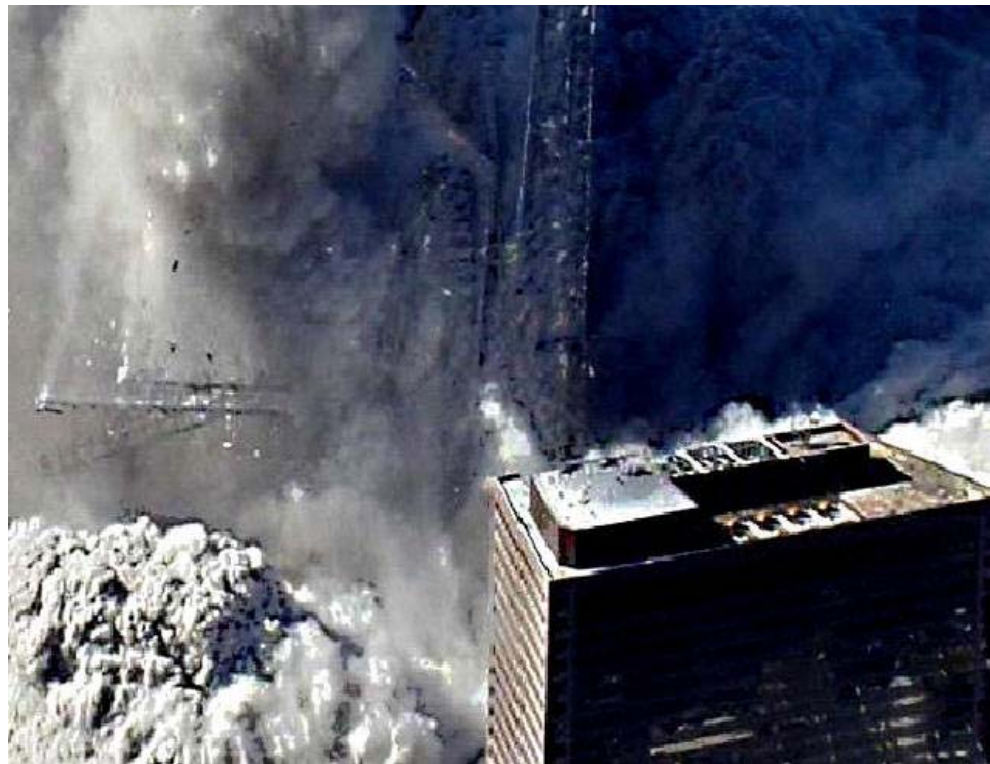
An intriguing photograph (below right) taken by Rob Miller, photojournalist with the New York Post, provides additional photographic evidence (Swanson, 2003) for the use of thermite or a sulfur-containing derivative such as thermate. We see debris and dust as WTC 1 collapses, with WTC 7 seen in the foreground, across the street from WTC 1. The photograph on the left shows, for comparison, the thermite reaction with a grayish-white aluminum-oxide dust plume extending upwards from the white-hot molten iron "blob" from the reaction (<http://www.cchem.berkeley.edu/demolab/images/ironred.jpg>).

Mr. Miller captured two ladder-like structures in his photograph (middle left; a cleaner photo is being sought), consistent with steel structures

observed in the core of WTC 1. Observe the grayish-white plumes trailing upward from white "blobs" at the left-most extremities of the upper structure. (The lower structure is mostly obscured by dust.)

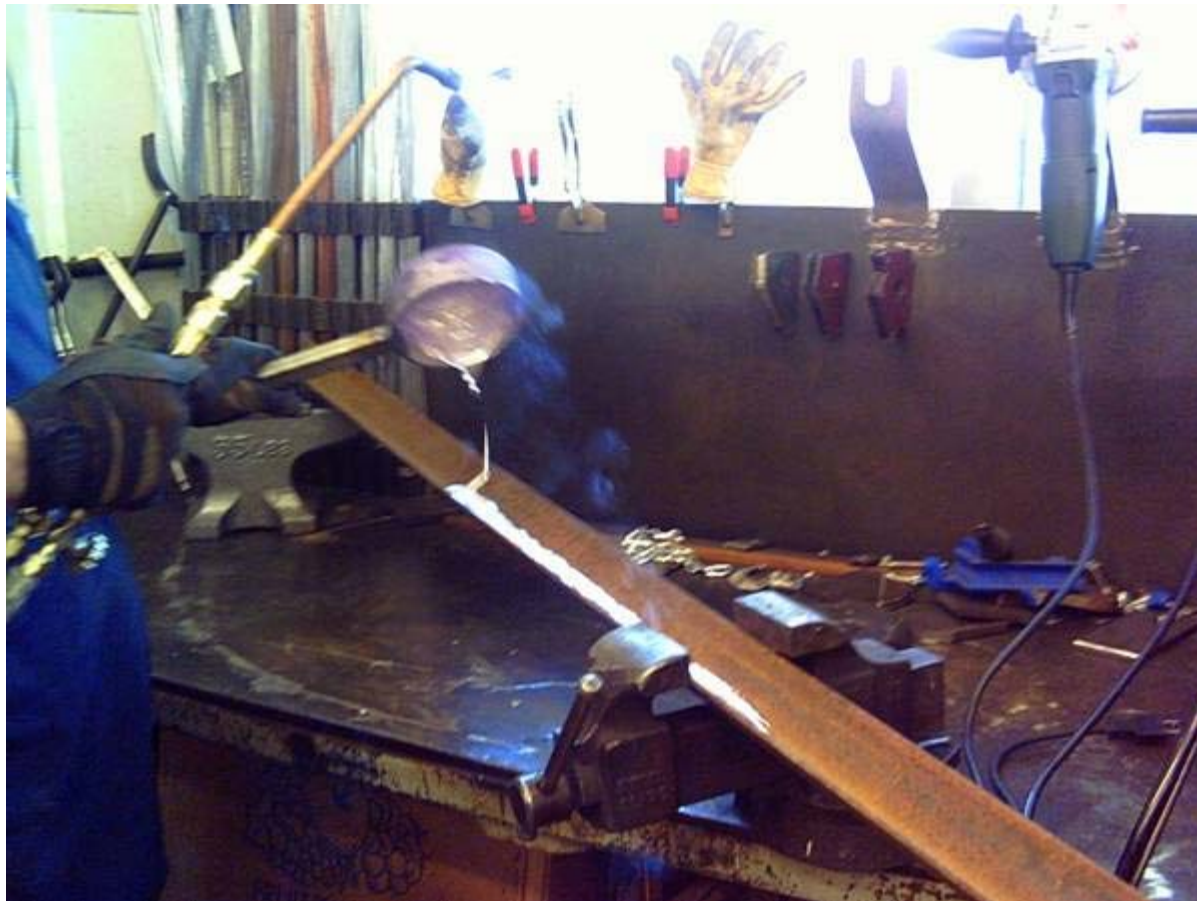
[See Greening, 2006] We also noted that while the steel pan holding the aluminum glowed red hot, the molten aluminum inside retained its silvery color, adding to the evidence that the molten metal dripping from the South Tower shortly before its collapse was NOT molten aluminum-- besides the fact that the salmon-yellow color of the molten metal (video clip above) implies a temperature too high for the dark-smoke hydrocarbon fires burning in the building.

Molten aluminum poured onto rusted steel: no violent reactions observed at all.

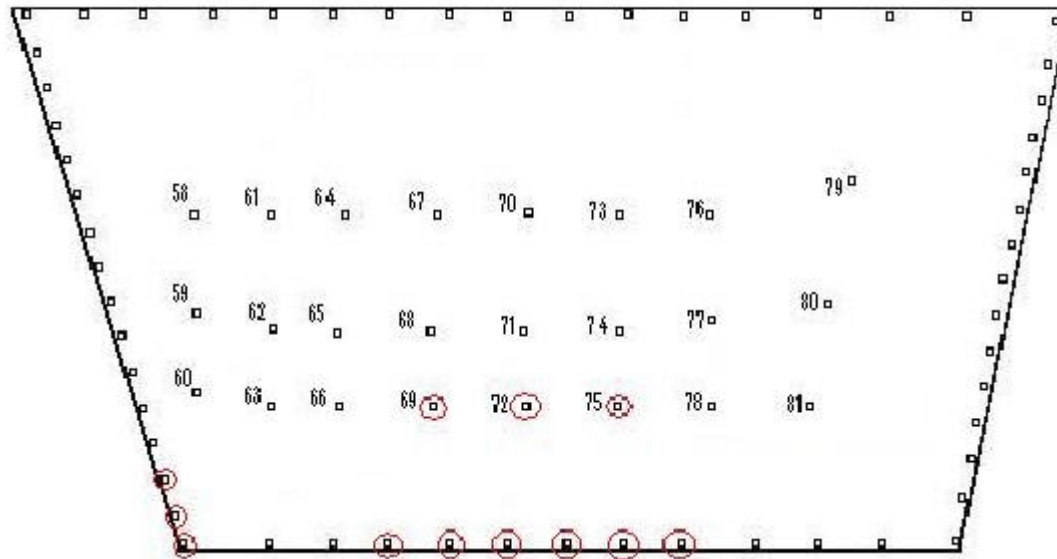
Diagram showing steel-column arrangement in WTC 7, view looking down on the roof. Circled columns were possibly damaged due to debris from WTC 1 collapse, some 350 feet away (NIST, 2005) so the damage was clearly non-symmetrical, and evidently, none of the core columns was severed by falling debris. WTC 7 was never hit by a plane.

As you observed ([link above](#)), WTC 7 collapsed rapidly and nearly-straight-down symmetrically -- even though fires were randomly scattered in the building. WTC 7 fell about seven hours after the Towers collapsed, even though no major persistent fires were visible. There were twenty-four huge steel support columns inside WTC 7 as well as huge trusses, arranged non-symmetrically, along with some fifty-seven perimeter columns, as indicated in the diagram below (FEMA, 2002, chapter 5; NIST, 2005).

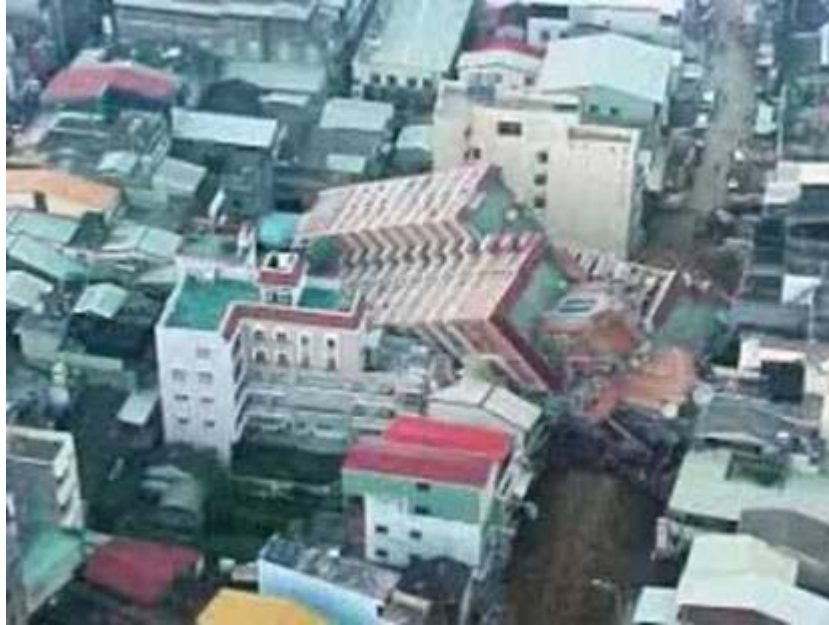
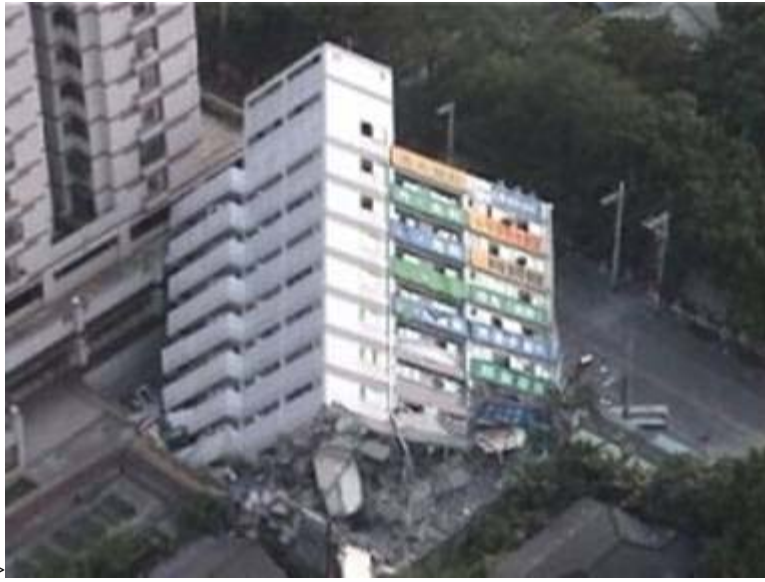
Non-symmetrical
collapse of tall buildings, consistent with the Law of increasing entropy when due
to random causes (approximately 9+ stories, here due to earthquakes).

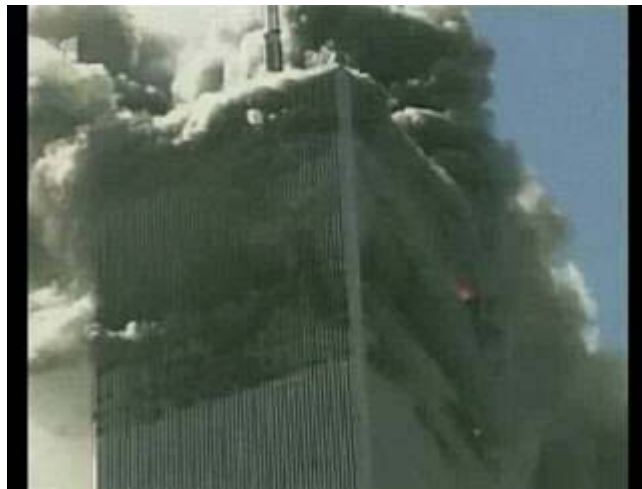
North Tower showing antenna (top) at beginning of collapse.

Yes, we can see for ourselves that the antenna drops first from videos of the North Tower collapse. (See http://911research.wtc7.net/wtc/evidence/videos/wtc1_close_frames.html; also <http://home.comcast.net/~skydrifter/collapse.htm>.)

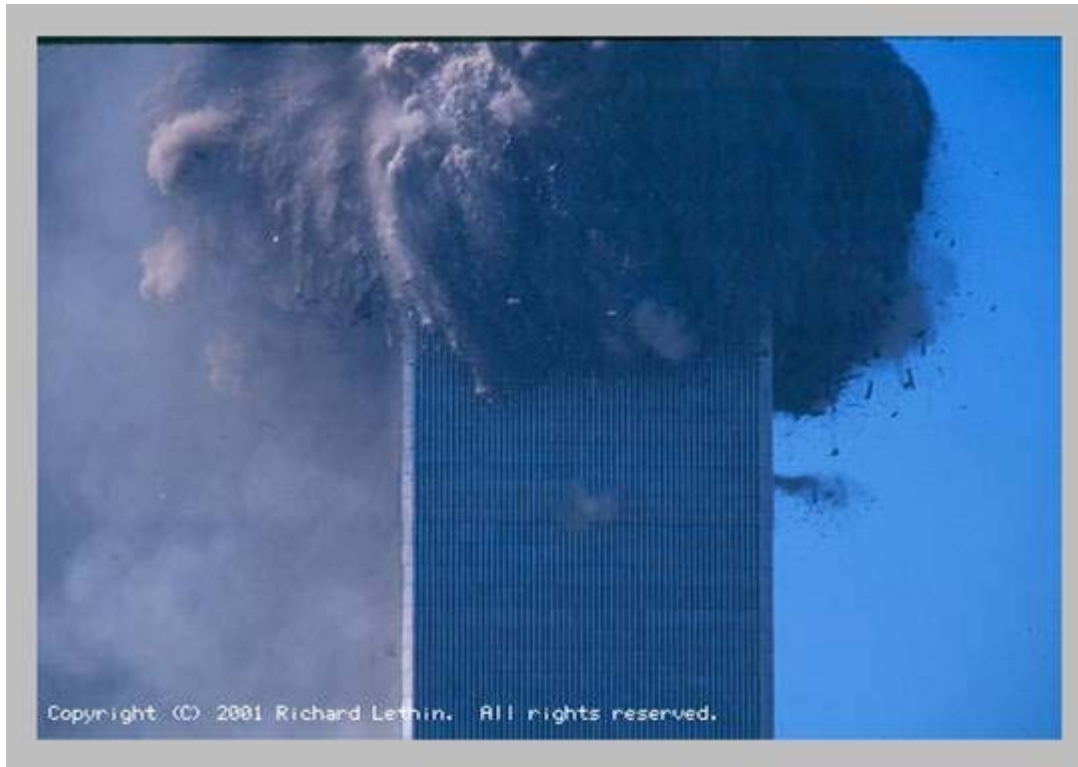
North Tower during top-down collapse.

Notice mysterious horizontal plumes far below pulverization region.

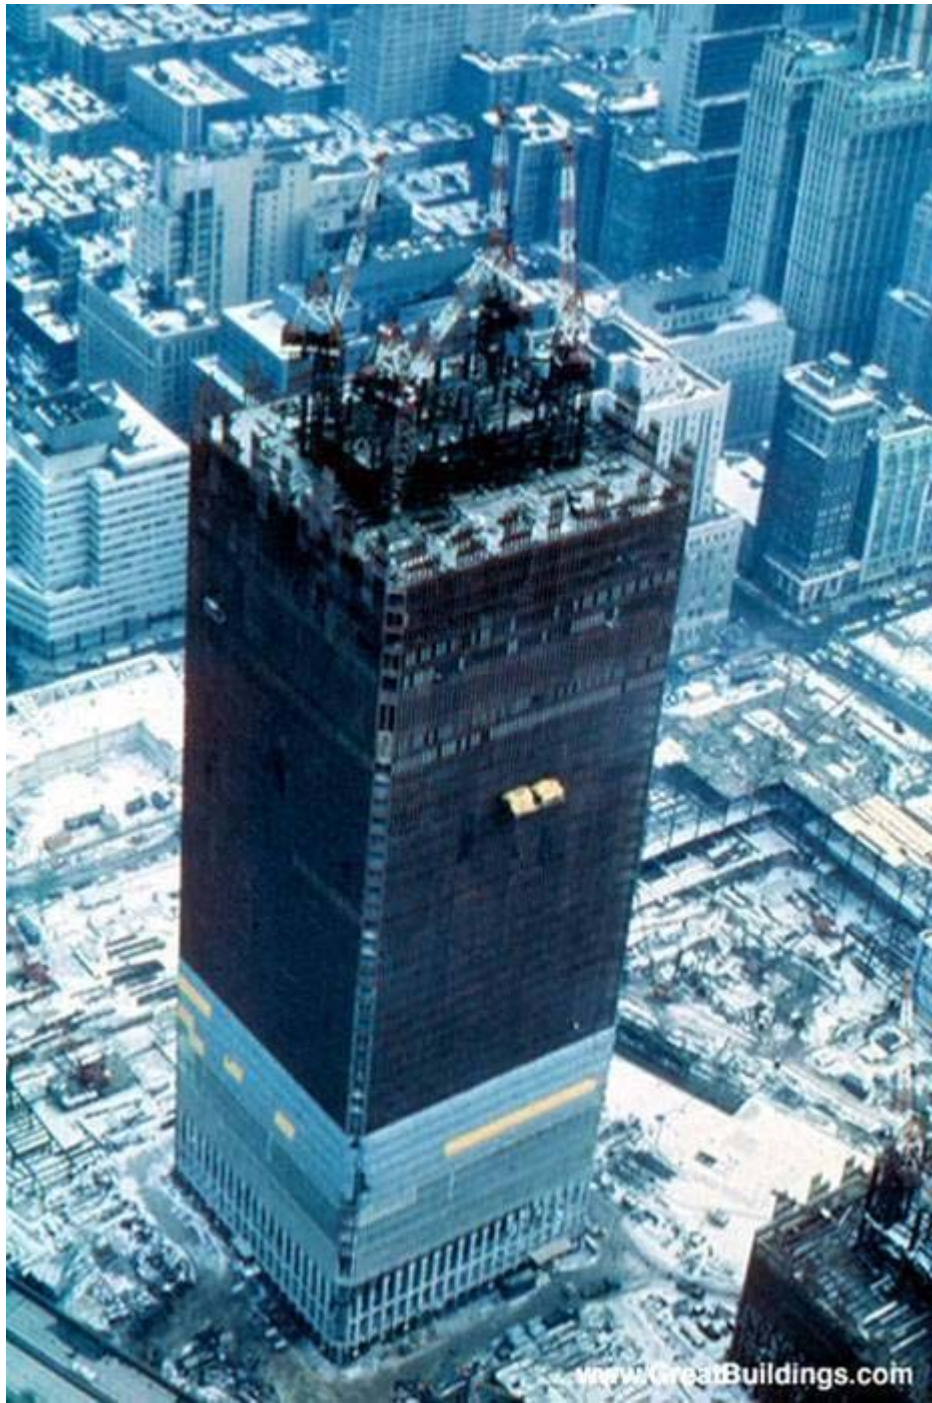
The WTC towers were

solidly constructed with 47 steel core

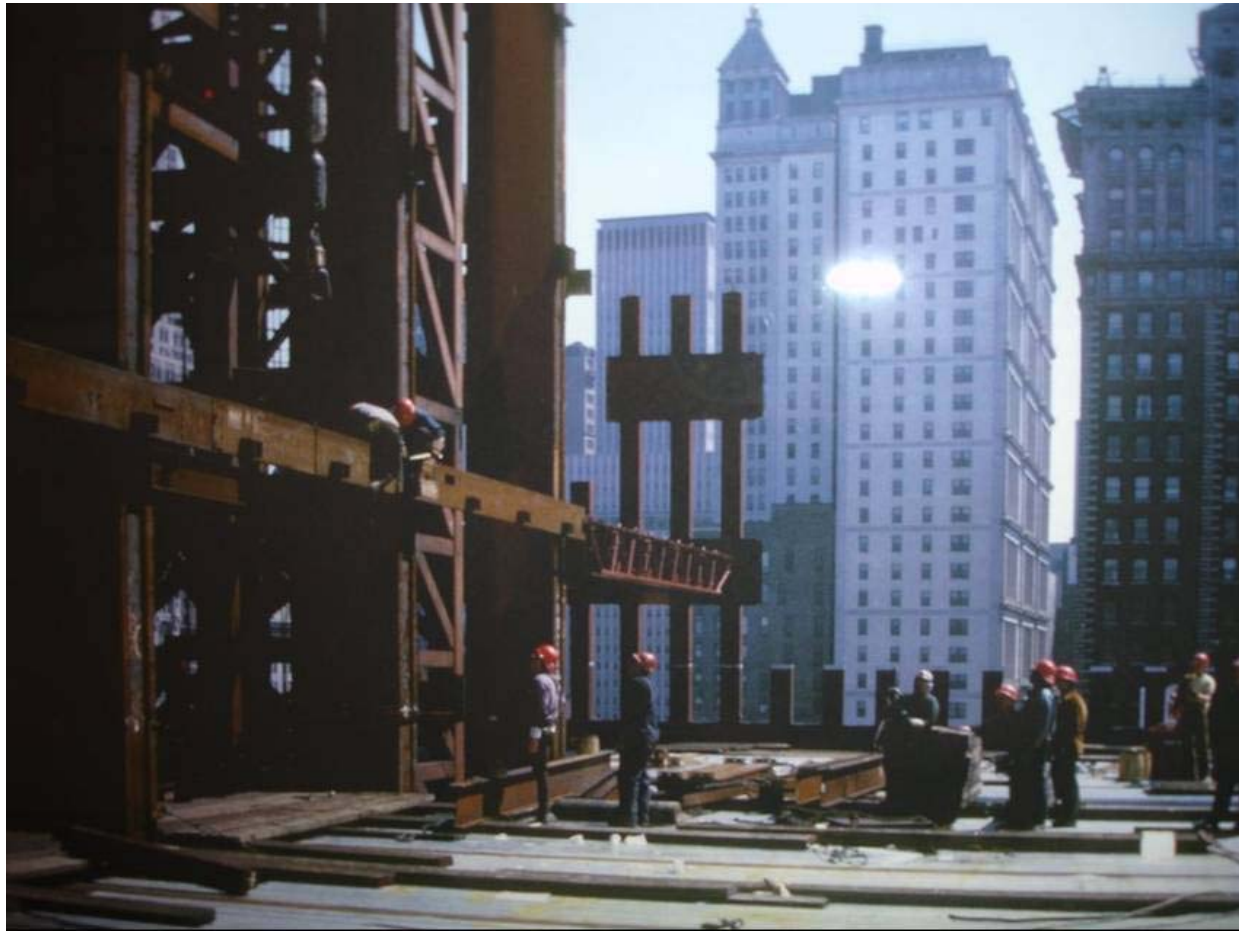
Steel-frame: Huge core (left)
is an enormous heat sink.
Notice workers standing on floor pan which is
firmly attached to the interconnected core columns.

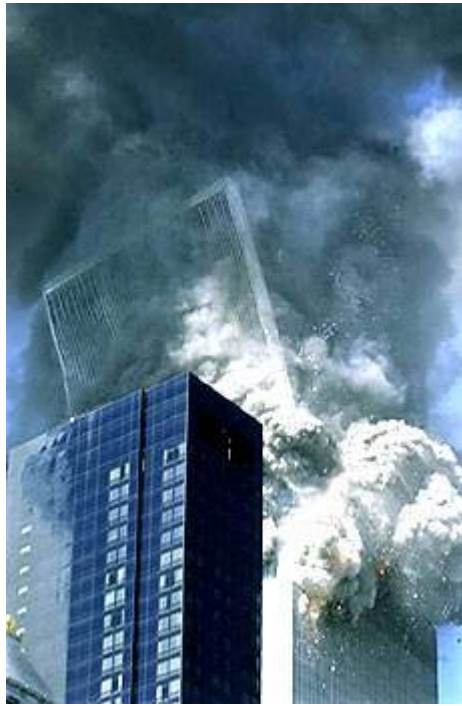
Top ~ 30 floors of South Tower topple over.
